Manhole Inspection Summary

Manhole # S37W1_040MH

Record Plat: **37W1** Node: **040** Status: **New Manhole (Not in GIS)** Insp Date: **12/12/07 12:00 AM**

Location Address: **3645 Potee St**

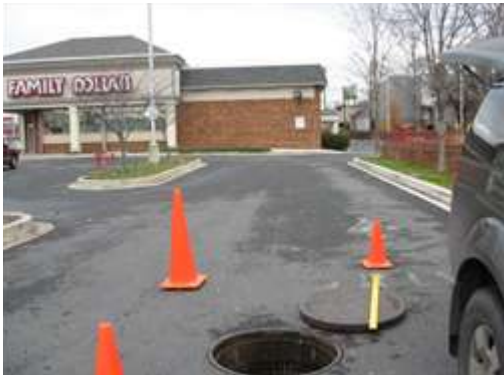
Location View

W. Garrett/ Family Dollar Parking Lot

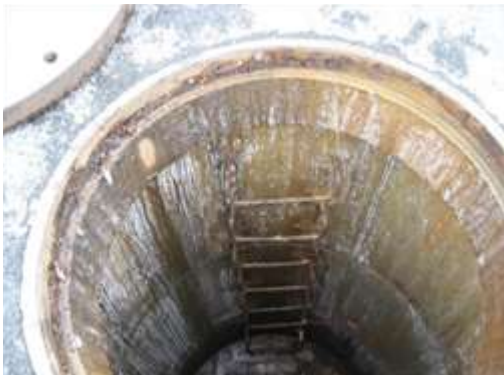
Steps Count: **8** Missing: **0** ☒ **Corroded**

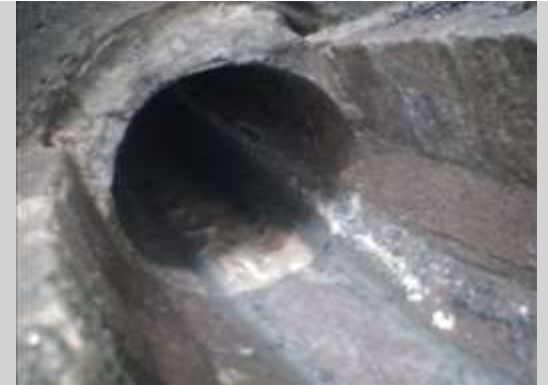
12 O'Clock Outflow

10 in. Circular Gravity Sewer
Pipe Out @ 12 O'Clock

Pipe Height: **10.8** (in.) Rod and Bar (Angled)
Pipe Material: **Clay** ☐ Pipe Lined
Invert Depth: **10.10** (ft.) Flow Characteristics: **Fast**
Deposits: ☒ None ☐ Mud ☐ Sludge ☐ Debris ☐ Grease
Silt Depth: (in.) Deposits Extent:
Infiltration: **None** Pipe Seal Cond: **Cracked**

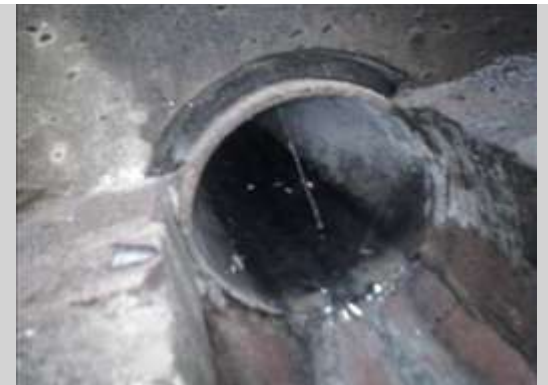
6 O'Clock Inflow

10 in. Circular Gravity Sewer
Pipe In @ 6 O'Clock

Pipe Height: **10.8** (in.) Rod and Bar (Angled)
Pipe Material: **Clay** ☐ Pipe Lined
Invert Depth: **9.68** (ft.) Flow Characteristics: **Fast**
Deposits: ☒ None ☐ Mud ☐ Sludge ☐ Debris ☐ Grease
Silt Depth: (in.) Deposits Extent:
Infiltration: **None** Pipe Seal Cond: **Sound**
